**Flood Control Project Maintenance
Levee Inspections**

Fall 2019 Levee Maintenance Deficiency Summary Report

Sacramento River Basin

NA0003	Overall LMA Rating	Total LMA Miles						
Butte County Department of Public Works	A	23.78						
Rated Item	Maintenance Deficiency				Enforcement		Design & System Obsolescence	
	M Miles	U Miles	M + 4U Miles	Threshold %	M Miles	U Miles	M Miles	U Miles
<i>Earthen Levee</i>								
Vegetation	0.35		0.35	1.47%	0.03	0.23		
Trim / Thin Trees	0.15		0.15	0.63%				
Encroachments	0.03		0.03	0.13%	2.61	0.48		
Animal Control	0.03		0.03	0.13%				
Slope Stability	0.10		0.10	0.42%				
Erosion / Bank Caving	0.01		0.01	0.04%				
<i>Supplemental</i>								
DRAFT DWR UCIP Field Study					0.10			
DRAFT DWR UCIP LMA Responsibility								
<i>LMA Totals:</i>	0.67	0.00	0.67	2.82%	2.74	0.71	0.00	0.00

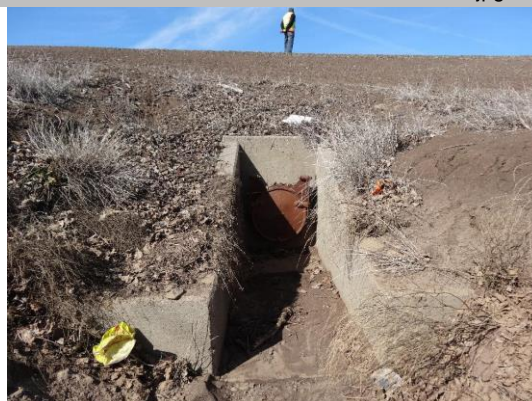
Photo 1 of 3 : UCIP_FA_2019_29705_54924.jpg

WS view: U typed concrete headwall, flapgate on levee slope.

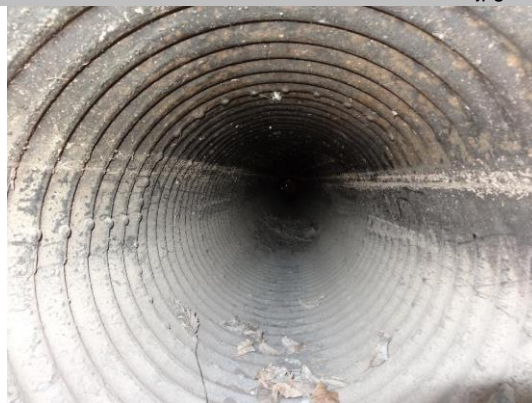
Photo 3 of 3 : UCIP_FA_2019_29705_54922.jpg

LS view: inside view of CMP on levee slope. Looks clean and clear.

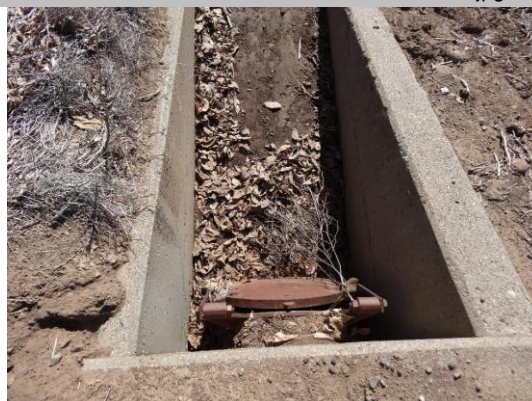
Photo 1 of 3 : UCIP_FA_2019_50142_55886.jpg

WS view: U type concrete headwall, flapgate on levee slope. Gate was not fully closed.

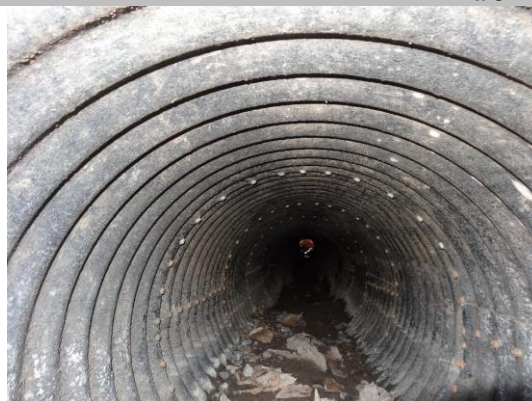
Photo 3 of 3 : UCIP_FA_2019_50142_55884.jpg

LS view: inside view of CMP on levee slope. Needs cleaning and clearing.

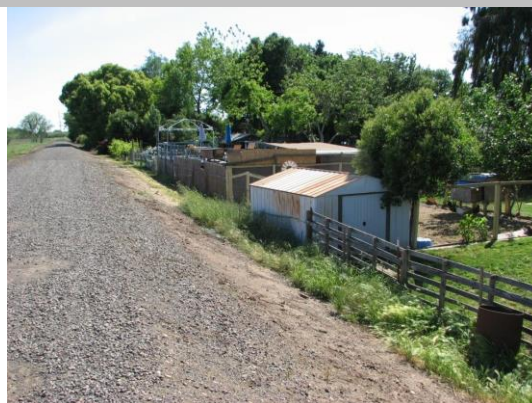
Photo 1 of 1 : FA_2019_NA0003_64_24_20190822_00004.jpg

View of a metal shed and fence along the landside toe.

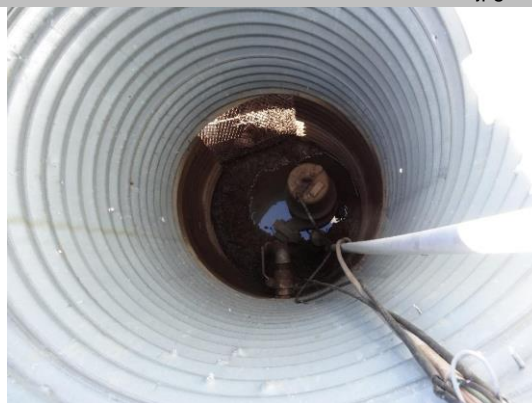
Photo 3 of 3 : UCIP_FA_2019_30291_55698.jpg

LS view: inside view of CMP riser. Pipe, gate valve, air vent, and submersible pump in the riser.

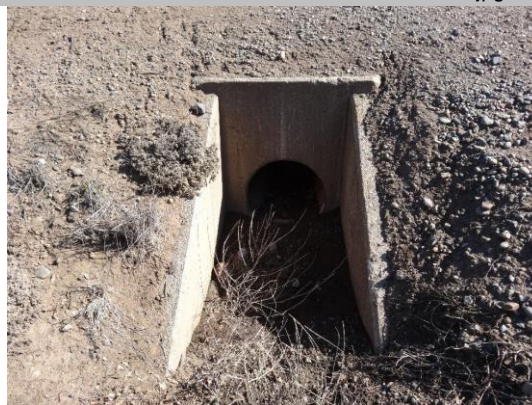
Photo 2 of 2 : UCIP_FA_2019_30294_55703.jpg

LS view: U type concrete headwall and CMP on levee slope. Debris blocking the inlet pipe.

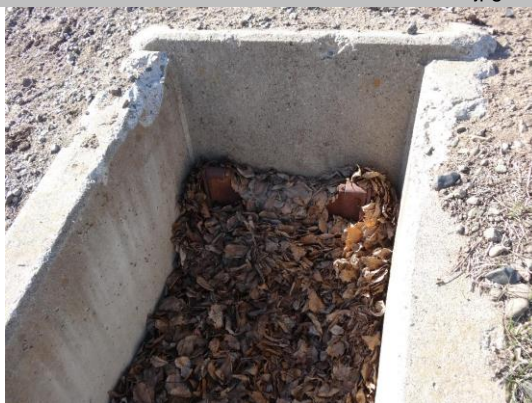
Photo 1 of 2 : UCIP_FA_2019_30295_55706.jpg

WS view: U type concrete headwall, flapgate on levee slope. Vegetation debris blocking the outlet.

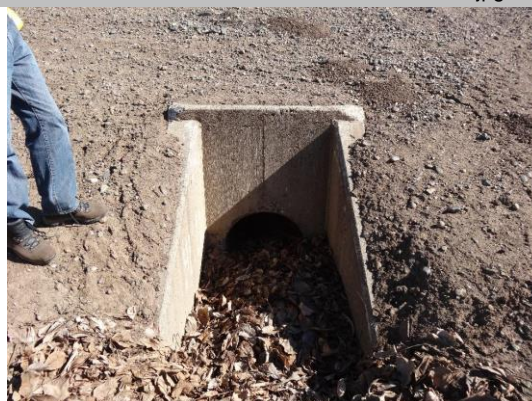
Photo 2 of 2 : UCIP_FA_2019_30295_55705.jpg

LS view: U type concrete headwall and CMP on levee slope. Vegetation debris blocking the inlet.

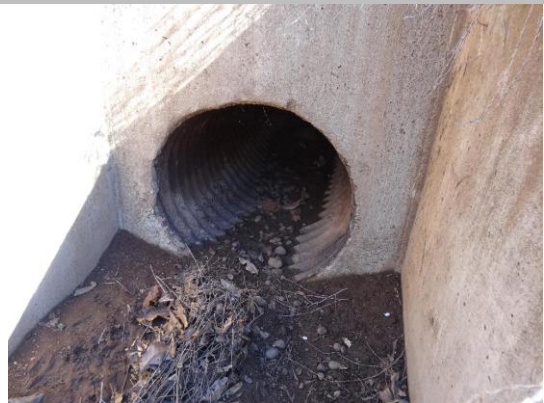
Photo 2 of 2 : UCIP_FA_2019_30312_55744.jpg

LS view: U type concrete headwall and CMP on levee slope. Needs cleaning and clearing of debris.

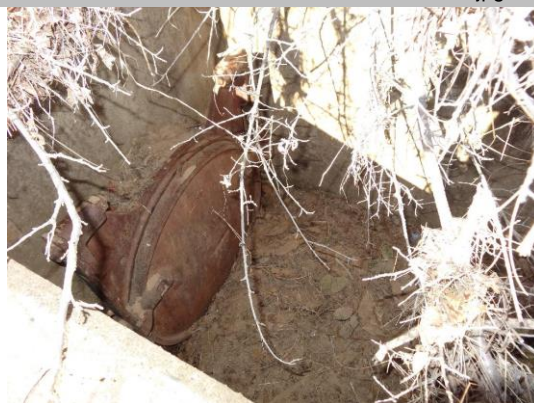
Photo 1 of 2 : UCIP_FA_2019_30388_55891.jpg

WS view: U type concrete headwall, pipe, and flapgate on levee slope. Vegetation/soil debris blocking outlet.

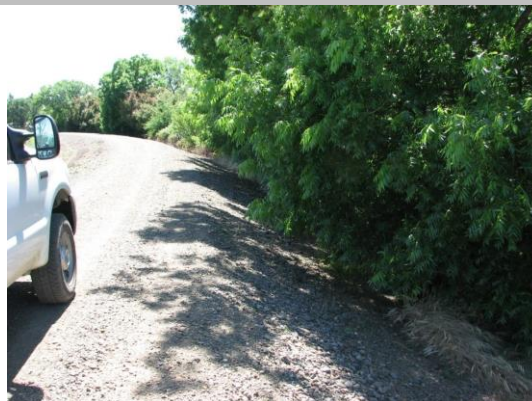
Photo 1 of 1 : FA_2019_NA0003_64_37_20190822_00015.jpg

04/25/2016: Trim trees on L/S slope.

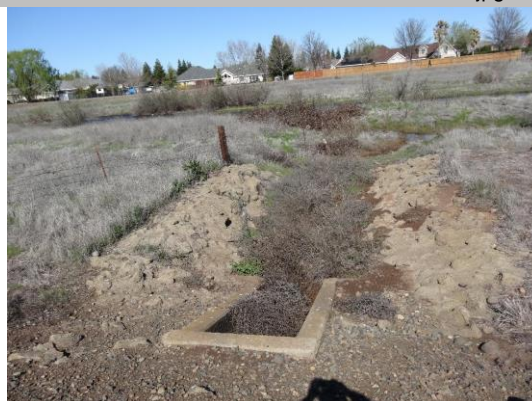
Photo 1 of 3 : UCIP_FA_2019_31667_57968.jpg

WS view: CMP culvert with U type concrete headwall. Vegetation debris blocking outlet box.

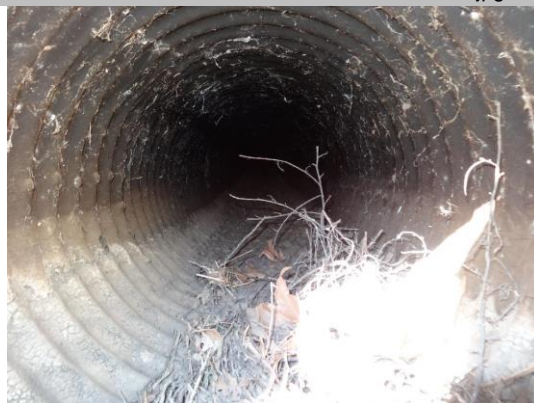
Photo 3 of 3 : UCIP_FA_2019_30403_55920.jpg

LS view: inside view of CMP on levee slope. Needs cleaning and clearing.

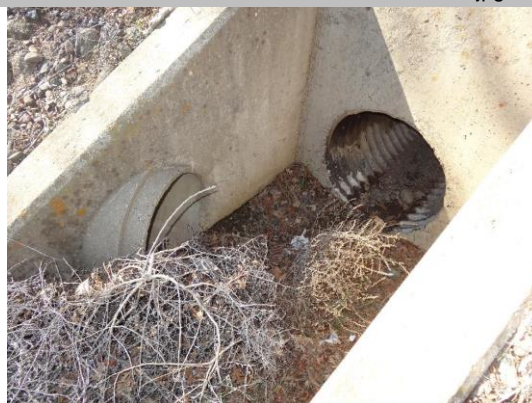
Photo 2 of 2 : UCIP_FA_2019_30743_56640.jpg

LS view: U type concrete headwall and CMP on levee slope. Vegetation debris and soil in inlet area.

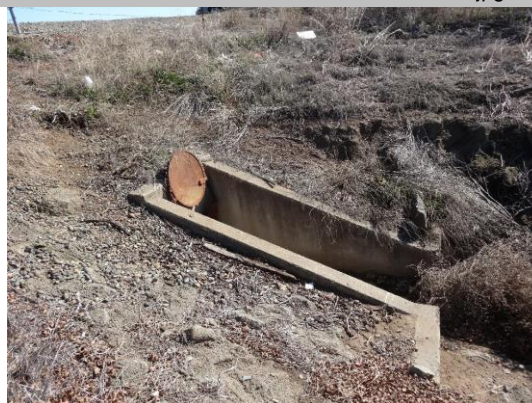
Photo 1 of 3 : UCIP_FA_2019_41375_56646.jpg

WS view: U type concrete headwall and flapgate on levee slope.
Vegetation debris on spillway.

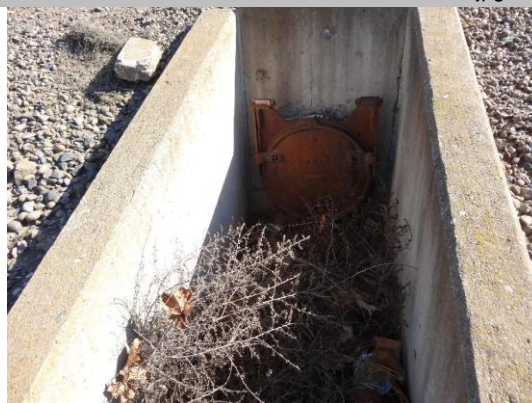
Photo 1 of 3 : UCIP_FA_2019_30763_56662.jpg

WS view: U type concrete headwall, pipe, and flapgate on levee slope. Vegetation debris blocking outlet.

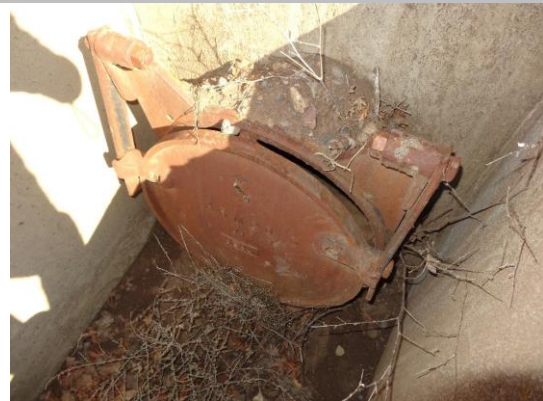
Photo 1 of 3 : UCIP_FA_2019_30783_56682.jpg

WS view: U type concrete headwall, pipe, and flapgate on levee slope.
Gate not fully closed. Debris and soil in outlet box.

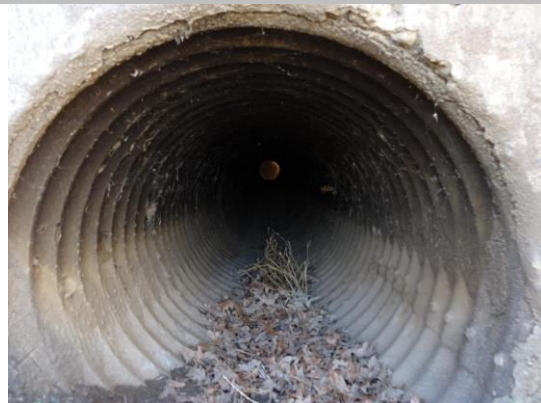
Photo 3 of 3 : UCIP_FA_2019_30783_56680.jpg

LS view: inside view of CMP on levee slope. Needs cleaning and clearing.

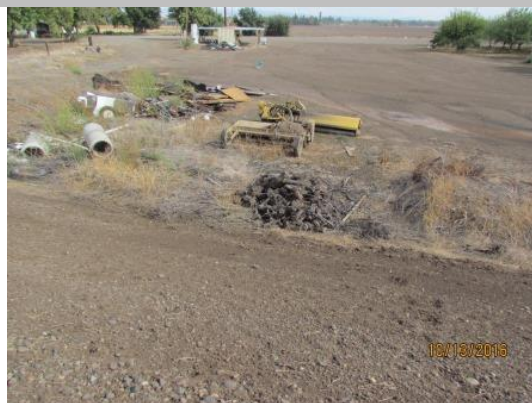
Photo 1 of 1 : FA_2019_NA0003_65_1_20190822_00001.jpg

View of the firewood and broken concrete pipes along the landside toe.

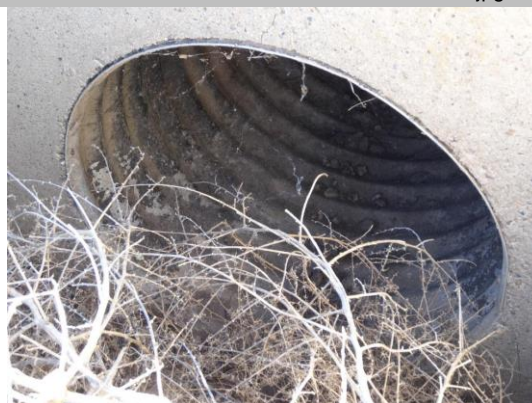
Photo 3 of 3 : UCIP_FA_2019_30803_56683.jpg

LS view: inside view of CMP on levee slope. Needs cleaning and clearing.

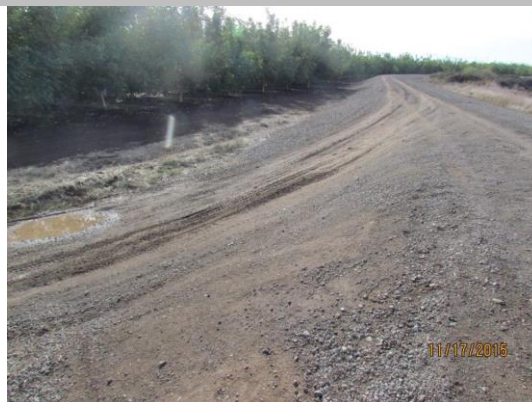
Photo 1 of 1 : FA_2019_NA0003_65_10_20190822_00003.jpg

View of the vehicle erosion along the landside slope.

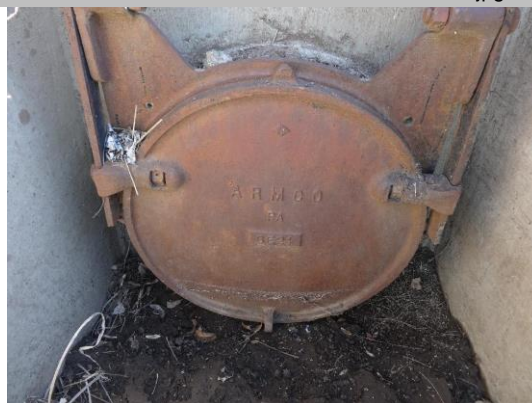
Photo 1 of 3 : UCIP_FA_2019_31028_56913.jpg

WS view: U type concrete headwall, pipe, and flapgate on levee slope.
Soil/mud on outlet box.

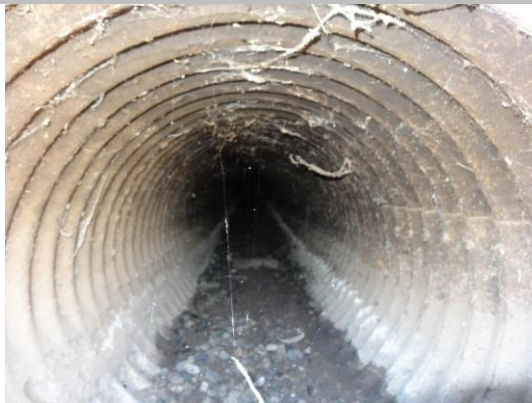
Photo 3 of 3 : UCIP_FA_2019_31028_56911.jpg

LS view: inside view of CMP on levee slope. Needs cleaning and clearing.

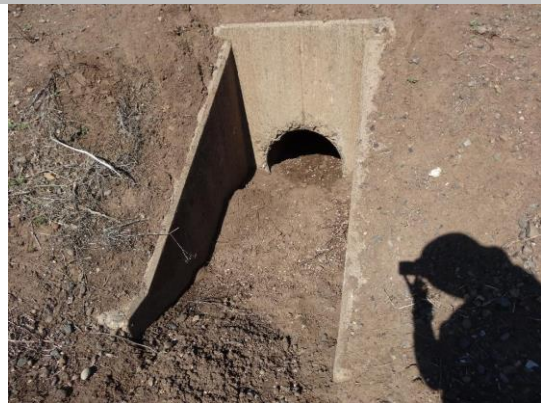
Photo 2 of 3 : UCIP_FA_2019_31031_56916.jpg

LS view: U type concrete headwall and CMP on levee slope. Soil/mud on inlet box.

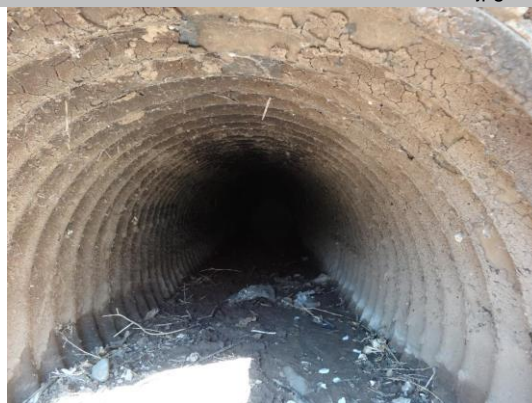
Photo 3 of 3 : UCIP_FA_2019_31031_56915.jpg

LS view: inside view of CMP on levee slope. Needs cleaning and clearing.

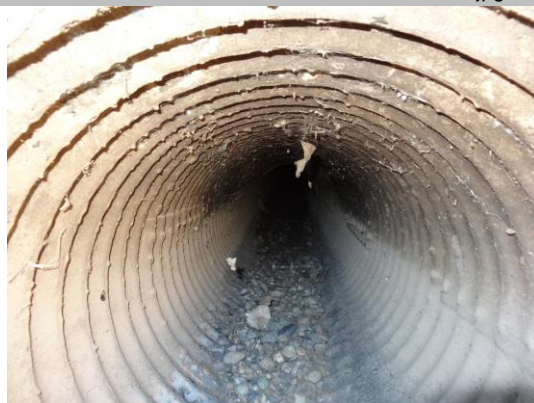
Photo 3 of 3 : UCIP_FA_2019_31034_56924.jpg

LS view: inside view of CMP on levee slope. Needs cleaning and clearing.

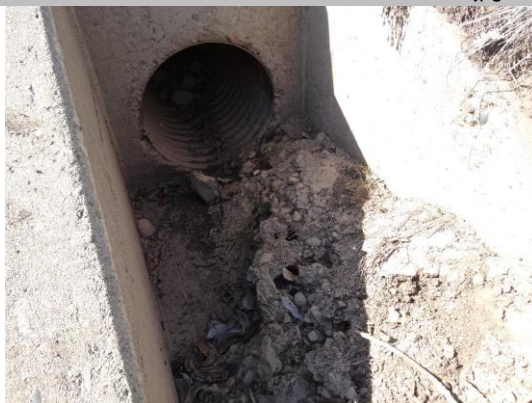
Photo 2 of 3 : UCIP_FA_2019_31085_56987.jpg

LS view: U type concrete headwall and CMP on levee slope. Soil/mud on inlet box.

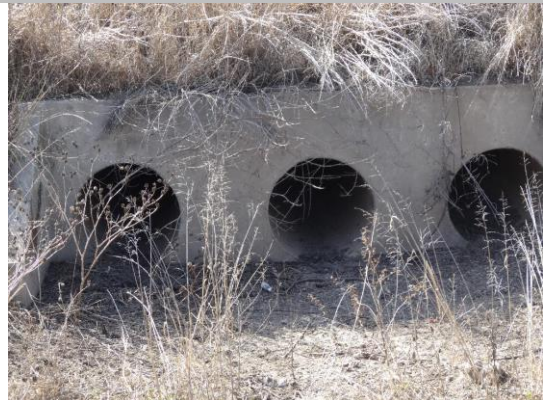
Photo 3 of 3 : UCIP_FA_2019_32085_58586.jpg

LS view: U type concrete headwall and CMPs on levee slope. Soil/mud on inlet box.

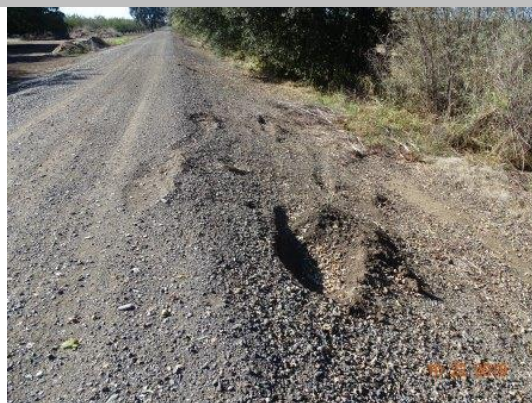
Photo 1 of 1 : FA_2019_NA0003_66_1_20191025_00001.jpg

View of depressions on the waterside slope. Fall 2019.

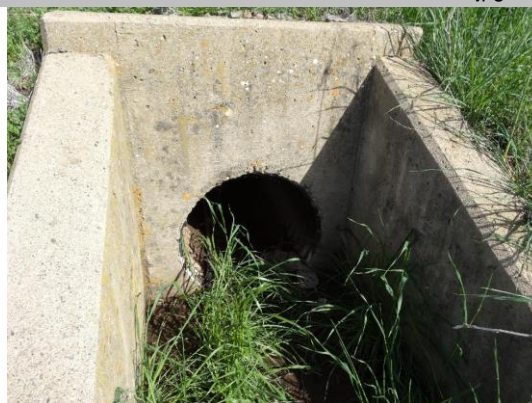
Photo 3 of 3 : UCIP_FA_2019_32124_58627.jpg

LS view: inside view of CMP on levee slope. Needs cleaning and clearing.

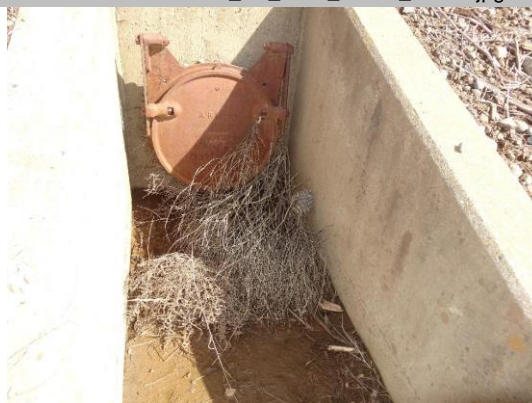
Photo 1 of 3 : UCIP_FA_2019_31901_58194.jpg

WS view: U type concrete headwall, flapgate, and CMP on levee slope.
Needs cleaning and clearing.

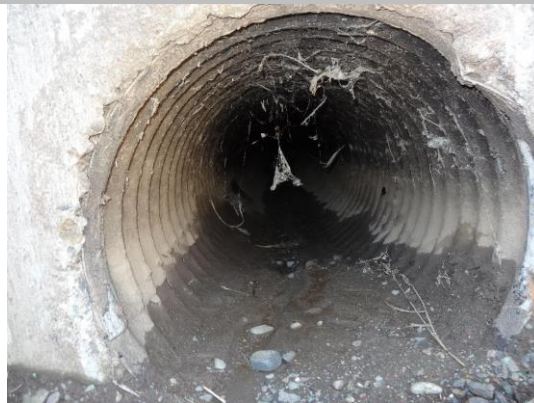
Photo 3 of 3 : UCIP_FA_2019_31901_58195.jpg

LS view: inside view of CMP on levee slope. Needs cleaning and clearing.

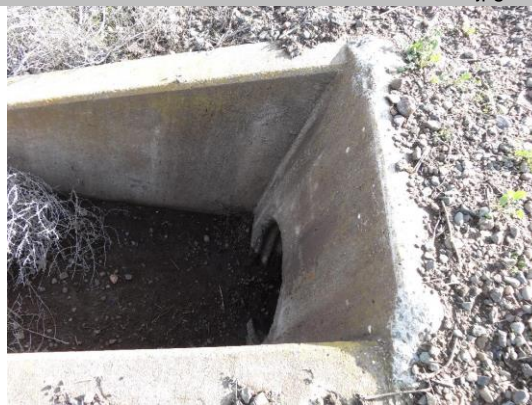
Photo 3 of 3 : UCIP_FA_2019_31902_58199.jpg

LS view: U type concrete headwall and CMP on levee slope. Soil/mud on inlet box.

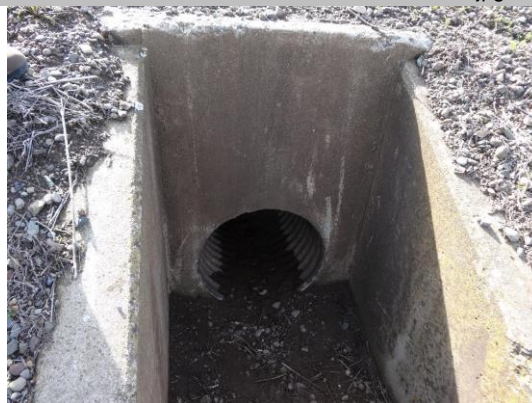
Photo 2 of 3 : UCIP_FA_2019_31864_58068.jpg

LS view: U type concrete headwall and CMP on levee slope. Soil/mud on inlet box.

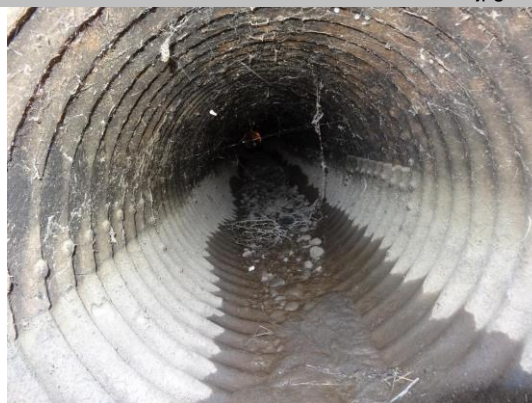
Photo 3 of 3 : UCIP_FA_2019_31864_58067.jpg

LS view: inside view of CMP on levee slope. Needs cleaning and clearing.

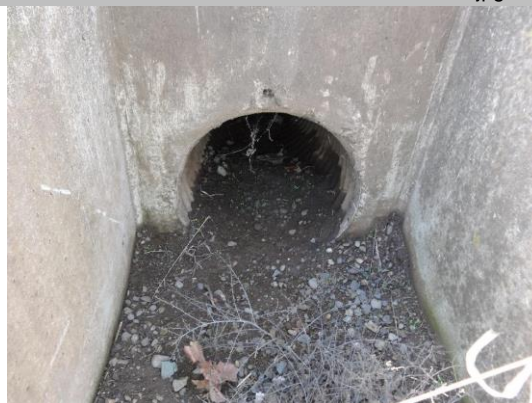
Photo 2 of 3 : UCIP_FA_2019_31856_58052.jpg

LS view: U type concrete headwall and CMP on levee slope. Soil/mud on inlet box.

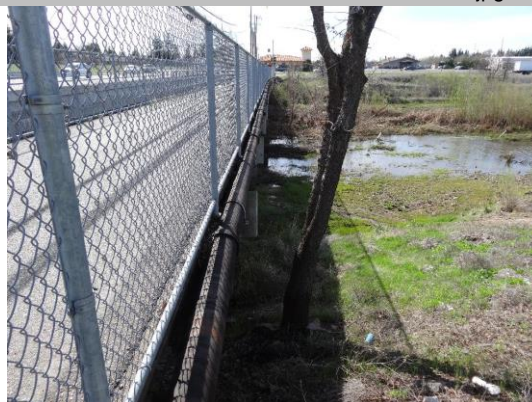
Photo 1 of 1 : UCIP_FA_2019_31851_58041.jpg

WS view: 6-inch steel pipe attached to Cohasset Road Bridge. Needs confirmation from LMA whether this is a gasoline.

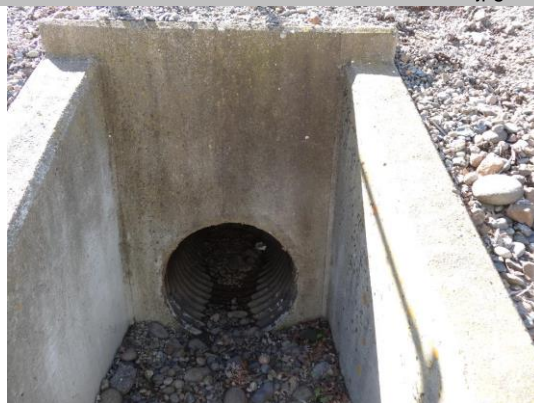
Photo 2 of 3 : UCIP_FA_2019_32023_58504.jpg

LS view: U type concrete headwall and CMP on levee slope. Pebbles and mud on inlet box.

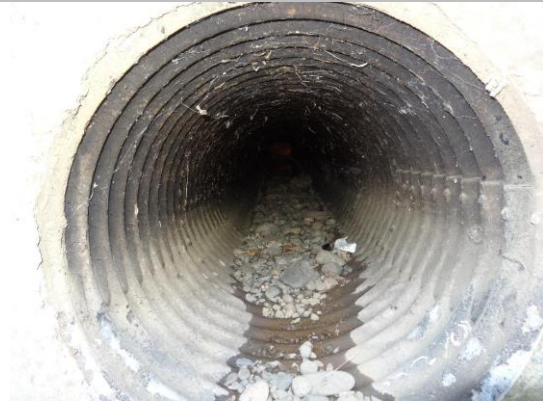
Photo 3 of 3 : UCIP_FA_2019_32023_58503.jpg

LS view: inside view of the CM pipe. Needs cleaning and clearing the pipe.

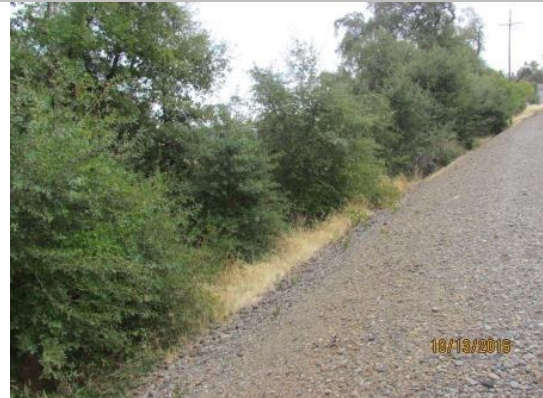
Photo 1 of 1 : FA_2019_NA0003_68_21_20190822_00006.jpg

View of the overgrown trees along the landside toe.

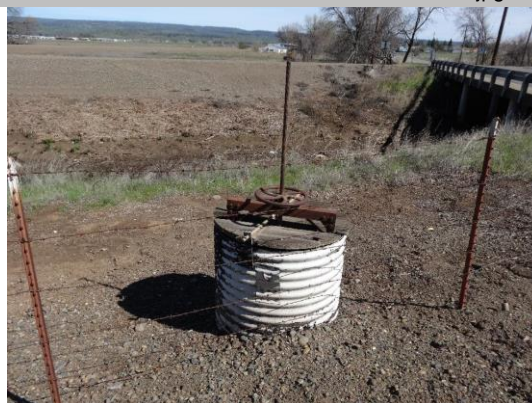
Photo 3 of 3 : UCIP_FA_2019_32144_58642.jpg

WS view: slide gate in CMP riser on waterside. No access to CMP riser.

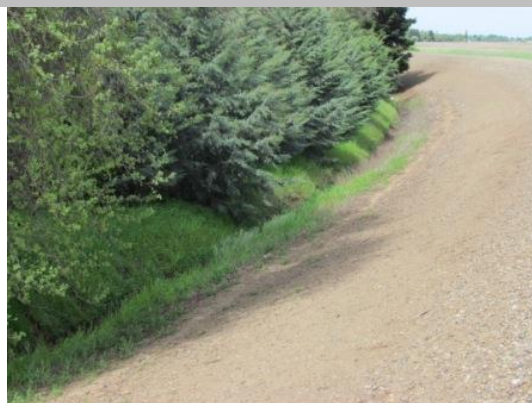
Photo 1 of 1 : FA_2019_NA0003_68_2_20190822_00002.jpg

View of ditch at the landside toe.

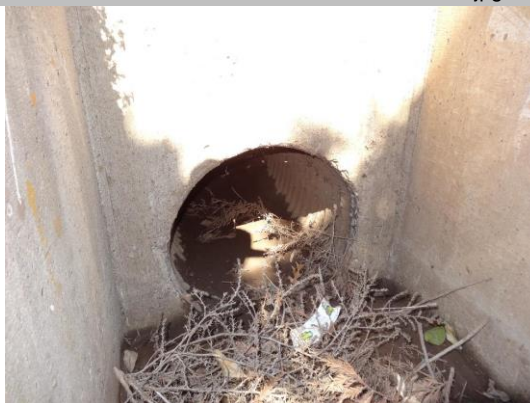
Photo 2 of 2 : UCIP_FA_2019_31964_58388.jpg

LS view: U type concrete headwall and CMP on levee slope. Vegetation debris and mud in inlet box.

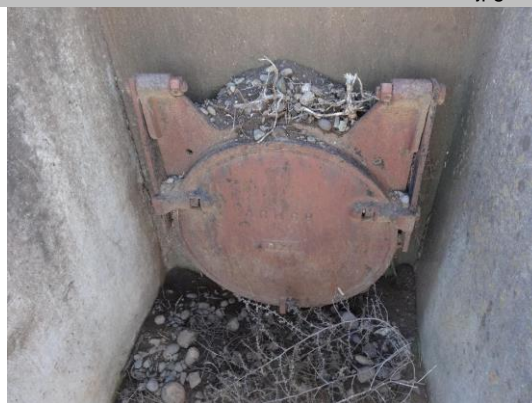
Photo 1 of 3 : UCIP_FA_2019_31965_58395.jpg

WS view: U type concrete headwall and CMP on levee slope. Vegetation debris and mud in outlet box. Needs cleaning and clearing.

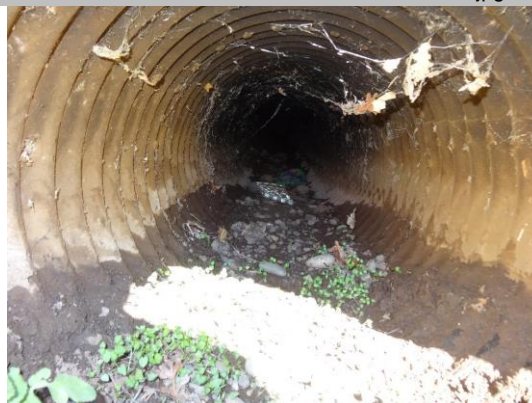
Photo 3 of 3 : UCIP_FA_2019_31965_58393.jpg

LS view: inside view of CMP on levee slope. Needs cleaning and clearing.
